WATERTOWN ARSENAL  
LABORATORY

EXPERIMENTAL REPORT

NO. WAL. 648/5

EVALUATION OF SHOCK PROPERTIES OF  
WELDED ARMOR JOINTS

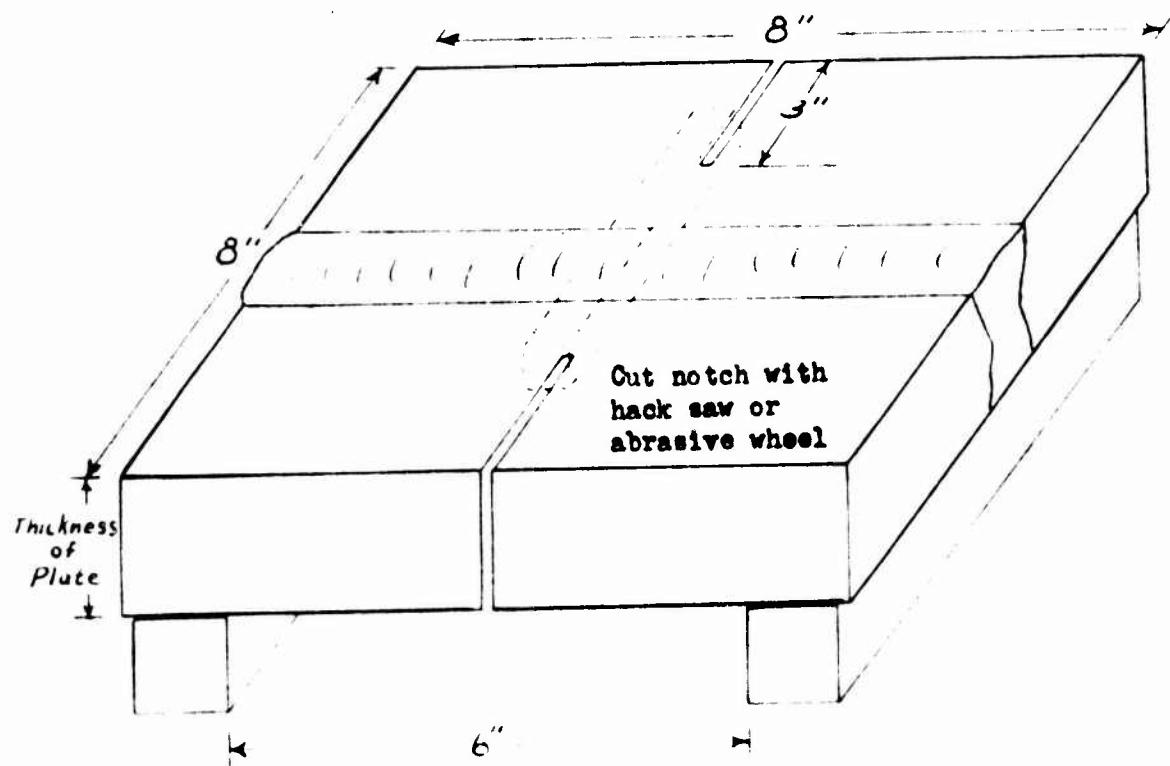
Figure 1

Nick-Break Fracture Test of Weld Joint

1/2 x 1/2 x 4 inch bar used as striking block. 1 x 6 x 6 inch plate placed on top of bar to prevent damage to steam hammer or drop weight.

Support on six-inch span; break with one blow  
of drop weight or steam hammer

The weld joint nick-break specimen of Figure 1, when fractured by a sharp blow at ordinary temperatures, affords a very severe test of impact resistance of a section through unaffected armor plate, weld heat-affected zone, and weld metal. A crystalline appearance of any of these metals indicates an area which will be subjected to brittle failure under a ballistic impact. Such failure will be greatly accentuated by the presence of any kind of defect providing a notch which may initiate failure in the low impact energy metal.

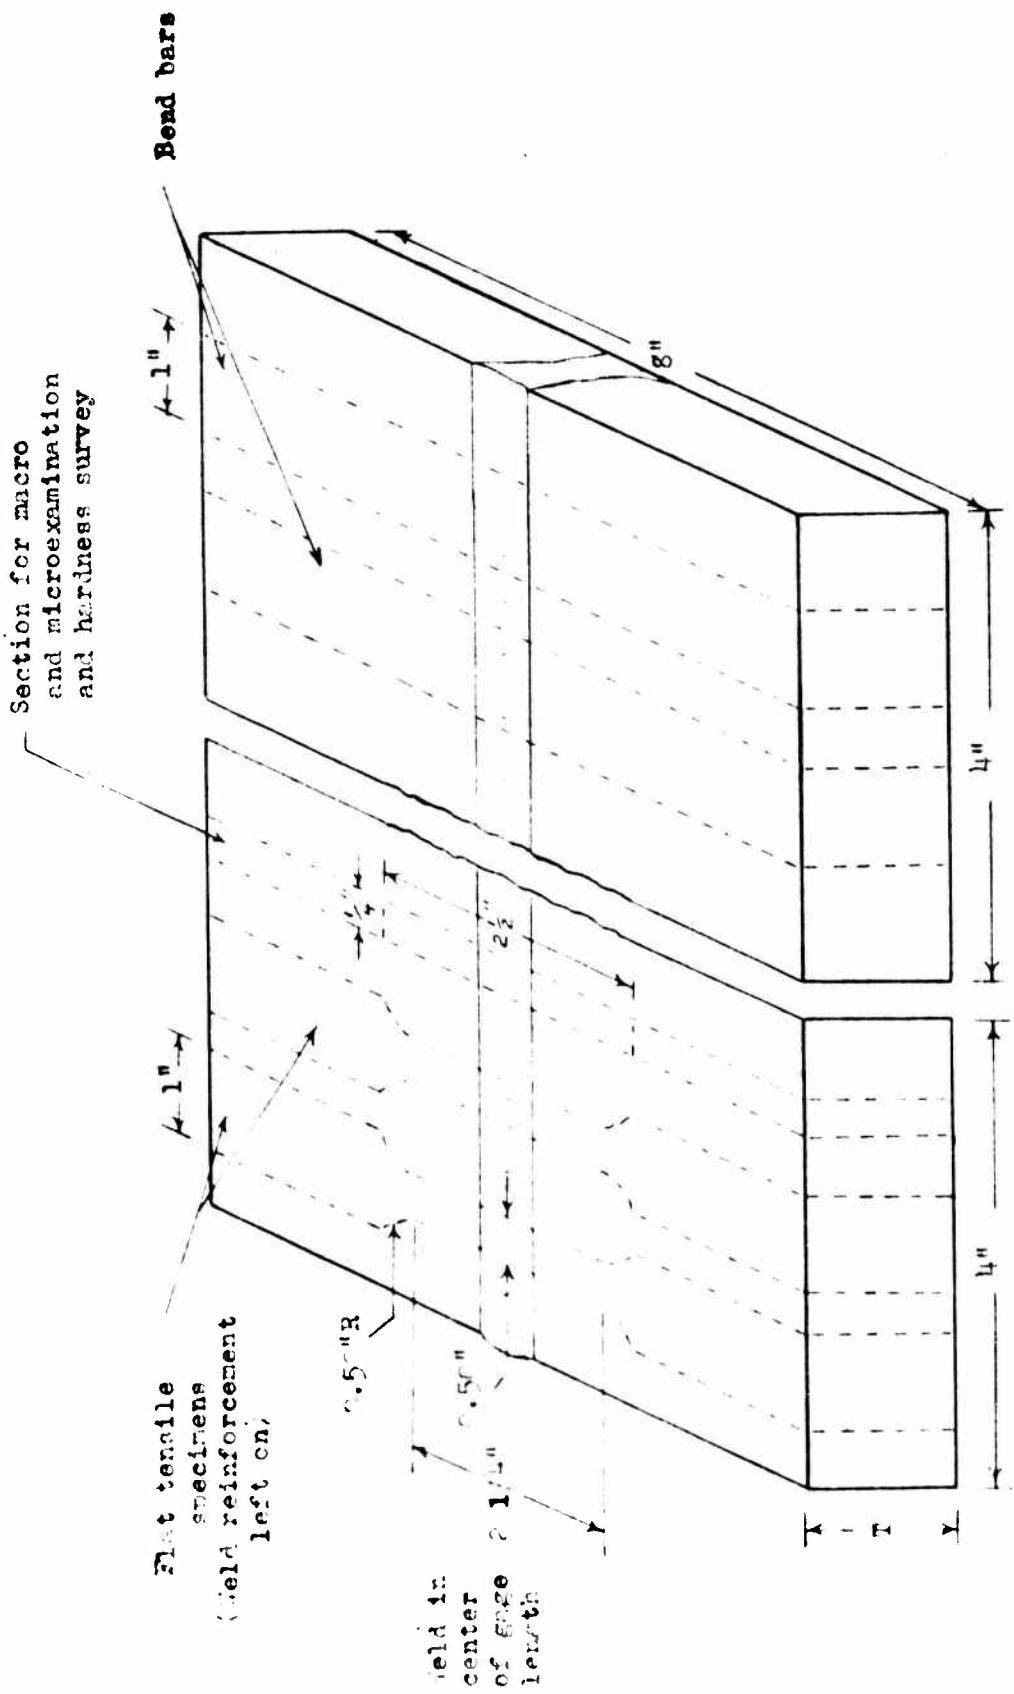
Figure 2. Layout and Dimensions of Bend Bars, Flat Tensile Specimens, and Section for Macro and Microexamination and Hardness Survey.

Layout and dimensions of specimens are shown in Figure 2. In addition, standard V notch Charpy bars were taken to determine relative impact energy of the weld metal heat-affected zone, and unaffected plate metal of a few representative plates.

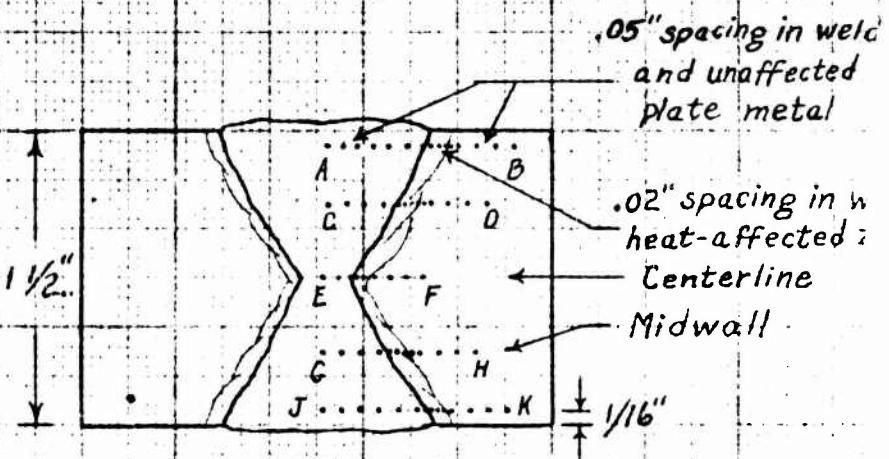
Location of Vickers-Brinell Hardness Impressions

Vickers-Brinell surveys were made at root, midwall, and near crown of weld cross sections after polishing through 000 emery paper. Specimens were then repolished and etched with 4% picral (unless otherwise noted) for microscopic examination, then further etched with hot acid (1 part H<sub>2</sub>SO<sub>4</sub>, 3 parts HCl, and 4 parts H<sub>2</sub>O) for macroscopic examination.

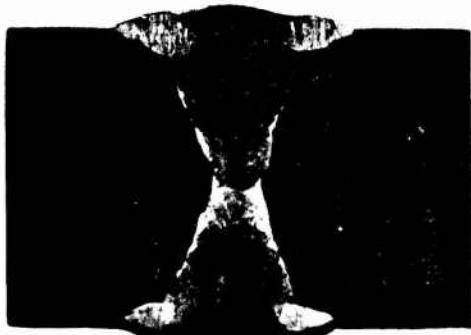
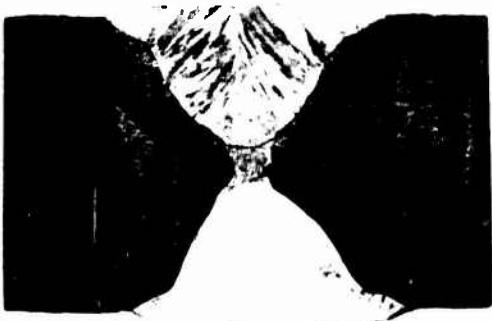
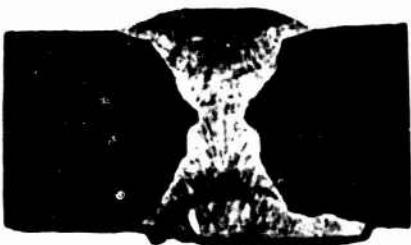
1 1/2 Inch Thick Test Plates

Austenitic Hand Welded Plate  
Midland KB 104

Austenitic Hand Welded Plate  
Ford W-235

Austenitic Hand Welded Plate  
Midland KB 113

Austenitic Unionmelt Welded  
Plate New York 47

Austenitic Hand Welded Plate  
Cadillac 143

Results of fracture test are given in Table IV. Figures 8 and 9 are photographs of typical weld joint fractures. It may be noted that:

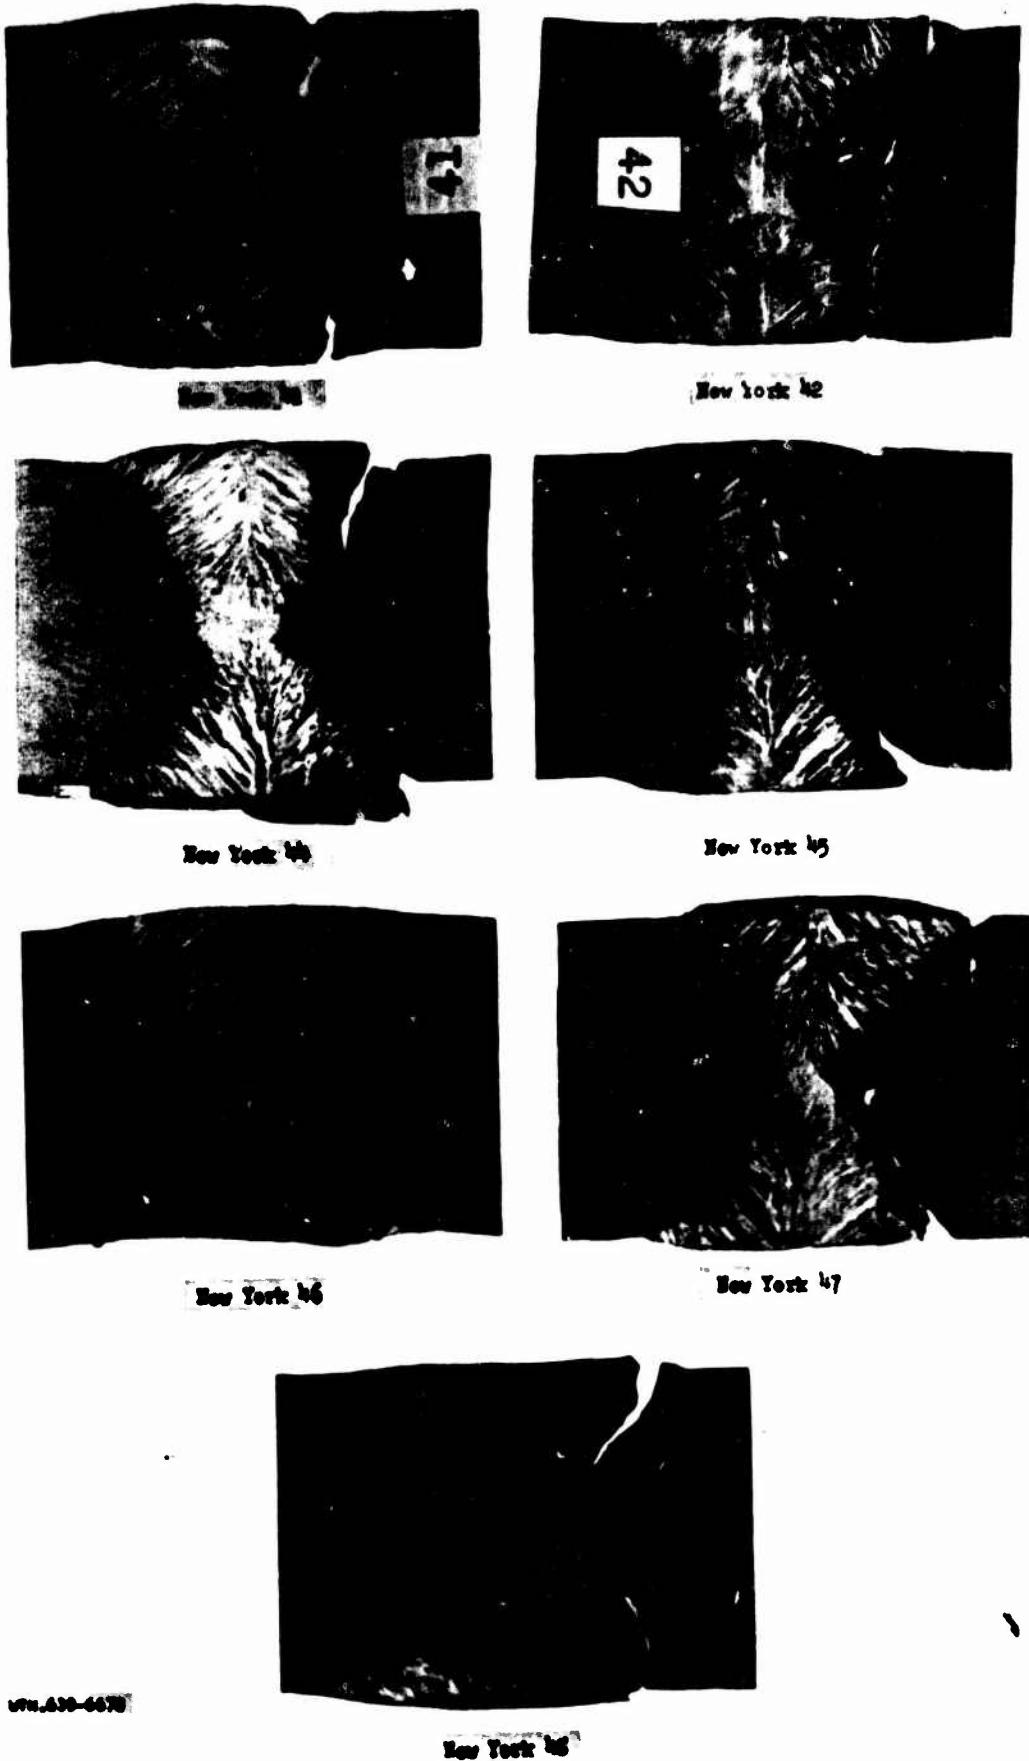
Figure 10. Aberdeen Proving Ground Photomicrographs of Sections through Ballistic Fractures.

At Aberdeen Proving Ground sections through ballistic fracture of some H plates are taken, macroetched and photographed. This was done on seven of the 1-1/2 inch thick Austenitic Unionmelt plates included in this report (Figure 10). It would be very desirable to have the path of ballistic fracture of a certain proportion of plates from each thickness and welding procedure group determined and reported.

1-1/2 inch thick plate - All plates with completely crystalline fracture of weld heat-affected zone showed excessive cracking during ballistic shock test. Figure 10, which is a reproduction of Aberdeen Proving Ground photomicrographs of sections through ballistic fracture, shows that the path of ballistic fracture of these plates was through the weld heat-affected zone. New York plate 46 in this Unionmelt welded group had a fibrous heat-affected zone in the fracture test (see Figure 8), and showed better ballistic performance with ballistic fracture principally through weld metal and fusion zone (see Figure 10).

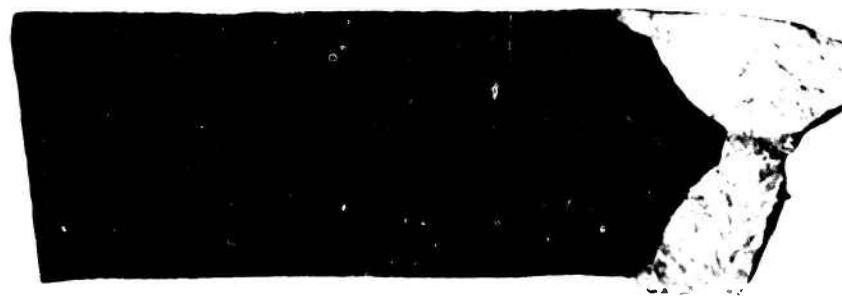
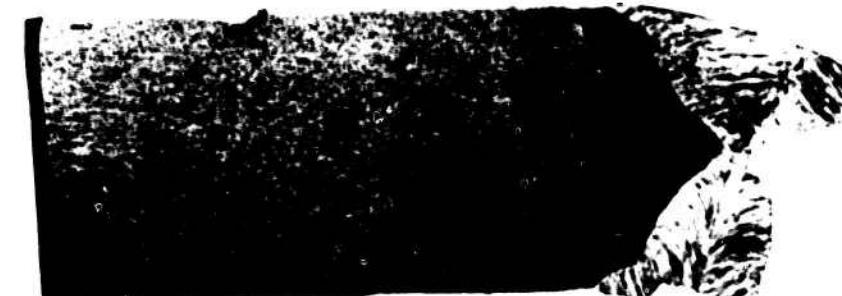
Figure 11. Fractures of Typical Bond Bars from  
1 1/2 Inch Thick Test Plates.

Austenitic hand welded plate Midland RE 104

Austenitic hand welded plate Midland RE 113

Austenitic Unionmelt welded plate New York 45

Austenitic Unionmelt welded plate New York 46

Austenitic Unionmelt welded plate New York 48

Table V gives location of fractures in the bend tests and typical tested bars are shown in the photographs of Figures 11, 12, and 13.

b. Fusion zone failures. Failure at the bond zone or in the weld metal immediately adjacent to the bond zone results in the type of fracture best illustrated by Midland RE-104 (Figure 11). Apparently a low impact energy zone exists near the fusion zone in many austenitic armor welds, but whether fracture proceeds through this area, depends to a large extent upon geometry at the crown of the weld, macrodefects (particularly incomplete fusion at the root of the weld) and external factors in the ballistic test. The cause of fusion zone fracture has been rather obscure, but will be discussed briefly under microexamination in this report and in more detail in a report now being prepared at this laboratory. Fusion zone failure in the bend test is undesirable and correlates with excessive cracking in the ballistic shock test.

When lined-up inclusions are present, the geometry of the weld is usually the determining factor as to the extent of fusion zone failure. Midland Plates EM-10<sup>4</sup> and 113 (Figure 11) both show large numbers of lined-up inclusions but the geometry of the latter weld is much superior and so are the ballistic and bend test results. The main benefit obtained from the so-called "annealing bead" technique appears to be in developing a geometry with less tendency toward initiation of fusion zone failures.

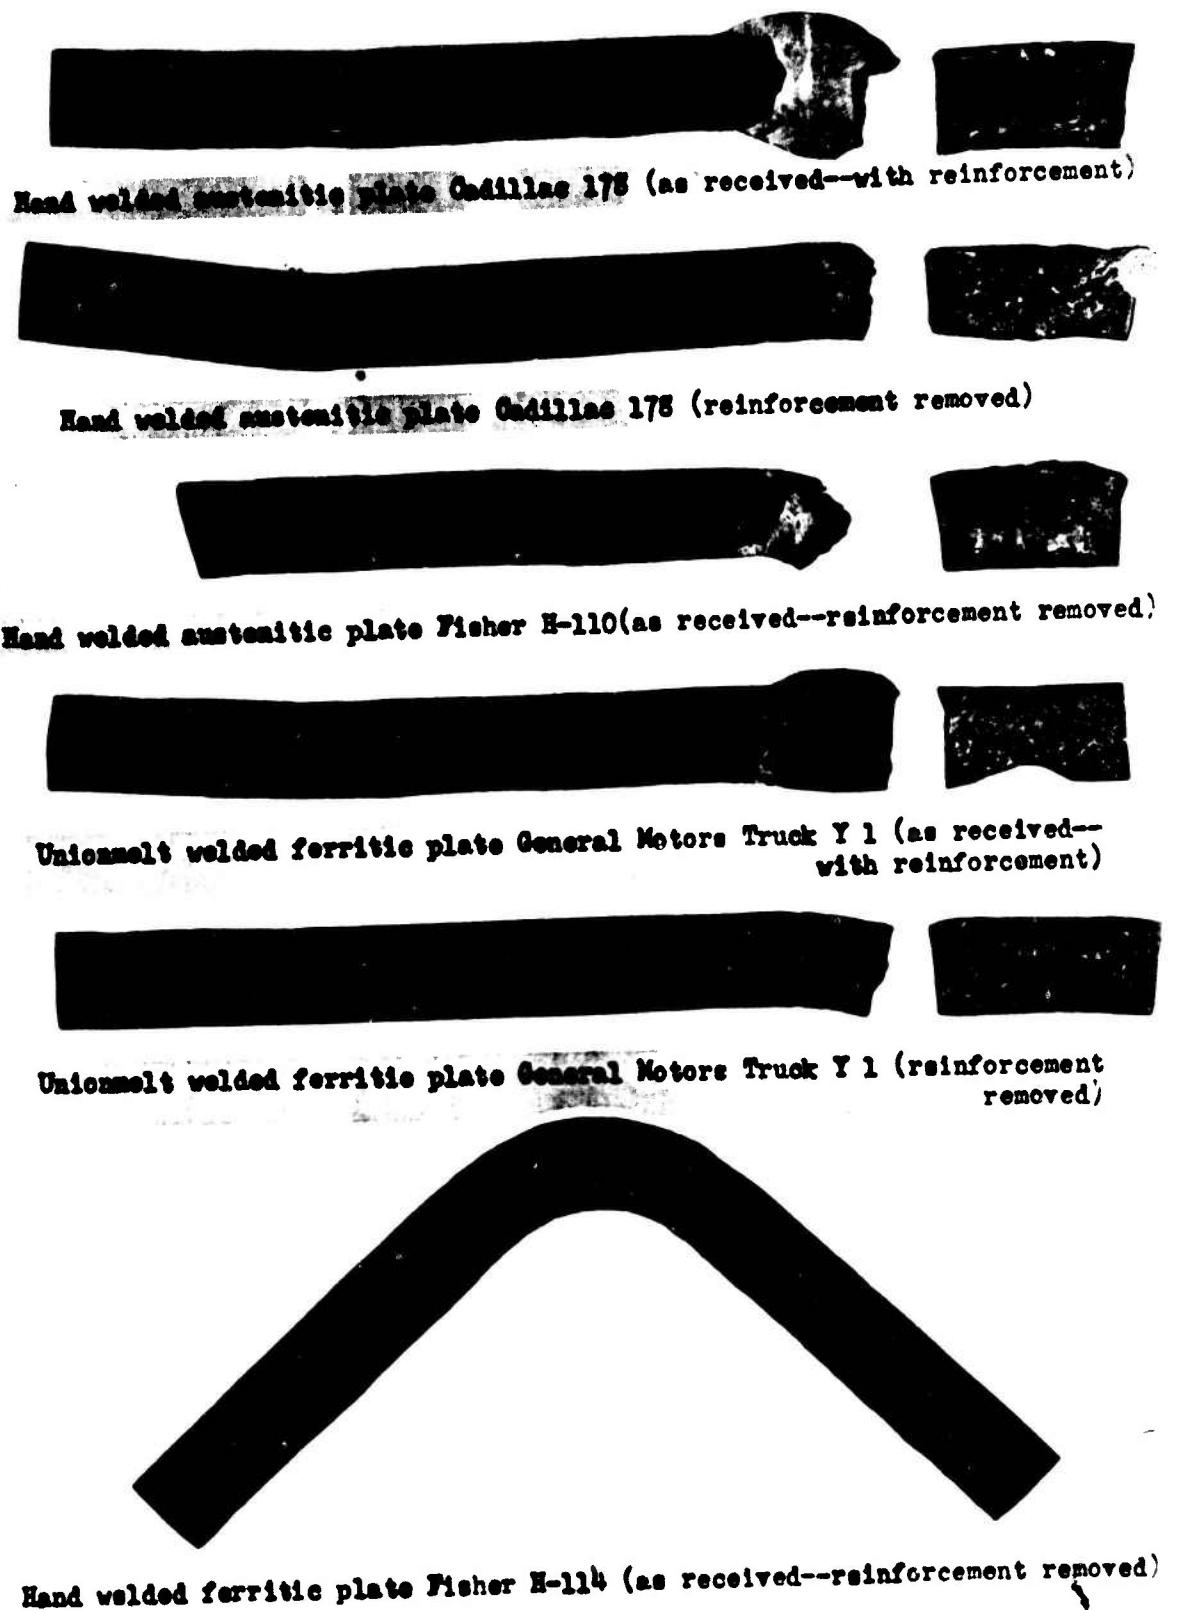
Figure 13. Fractures of Typical Bend Bars from  
1/2 Inch Thick Test Plates.

Weld reinforcement was ground flush with the plate surface prior to ballistic testing of a number of the plates. Figure 13 shows effect of removing the reinforcement on bend bars for two of the 1/2 inch plates which were ballistically tested with reinforcement. In both illustrations removing the reinforcement caused fracture to shift from fusion zone and heat-affected zone to weld metal. The practice of grinding reinforcements will obviously have a considerable influence on both ballistic and bend bar results, particularly in lighter gage plates. One-half inch thick plates hand welded with Mn-Mo ferritic electrodes and tested with reinforcement removed showed excellent performance in the drop weight bend test.

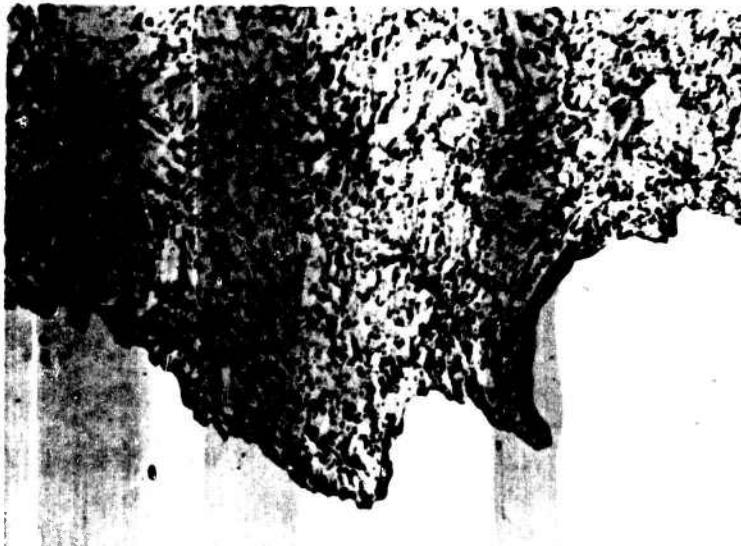
Charpy Value: 49 ft. lbs.

Fracture: Fibrous

Fracture: Crystalline

Figure 14. Fracture Modes of 0.8% Carbon Mn-Mo Armor Plate Heat-Treated by Two Different Methods to Equivalent Tensile Strength and Hardness Levels.

a. Weld heat-affected zones - In general a steel which has been quenched to martensite and tempered and has a microstructure consisting of very fine uniformly distributed carbide particles has relatively high impact energy. A steel with a heterogeneous microstructure consisting of high transformation temperature lamellar carbides has very low impact energy under severe conditions of testing. This is illustrated in Figure 14 showing photomicrographs of specimens of a .25 C Mn-Mo armor plate heat treated by two different procedures to equivalent tensile strength and hardness levels.

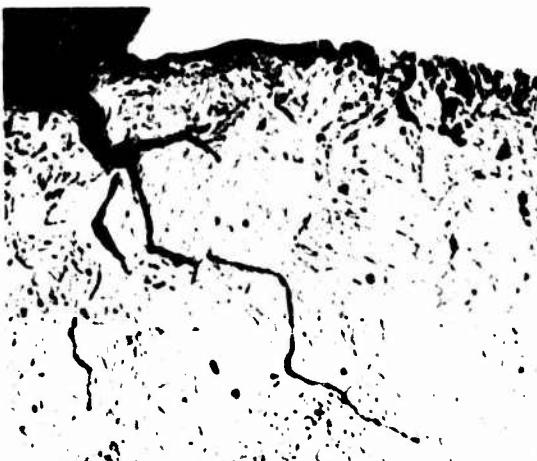
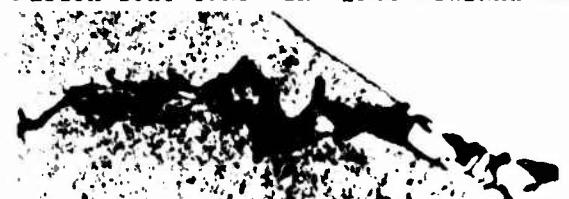
X250 Hydrochloric and Picric Acids Fusion zone and heat-affected zone cracks from area of incomplete fusion in Plate Ford W-235.

X100 Hydrochloric and Picric Acids Fusion zone crack in Plate Midland RE117.

X100 Hydrochloric and Picric Acids Weld and heat affected zone crack in Plate Midland RE113.

b. Fusion Zones - There is a pronounced tendency for austenitic hand welded plates to fail through the bond zone and this tendency is an indication of inferior ballistic performance as discussed in connection with the bend test. Careful examination of ballistic and bend test fractures disclosed three separate conditions which may lead to fusion zone failures: (1) Lack of fusion and fusion zone cracks. Lack of fusion at the root of New York Air Brake Unionmelt plates was disclosed in several tests and failure usually proceeded through this defect in bend tests. No extensive crack systems were observed.\* A few small cracks observed on macroexamination appear to be local defects which did not influence bend or tension test results to an appreciable extent. Photomicrographs in Figure 17 illustrate types of cracking observed. (2) Precipitation of carbides at weld-plate interface. Failure right at the bond line has been observed to a limited extent in a few plates. A characteristic very fine grained crystalline fracture is observed. Microexamination indicates that this condition is caused by a heavy precipitation of carbides at the weld-plate interface on reheating by subsequent welding passes as illustrated in the upper two photomicrographs of Figure 18. Heating a hand welded austenitic bend bar at 1350° F. for one hour produced a heavy carbide precipitation and caused the bar to break without deformation and almost entirely along the tempered interface. Very limited carbide precipitation occurs in hand welded plates, but the condition tends to be more serious when large electrodes are used and in Unionmelt welded plates. The presence of a very low impact energy heat-affected zone in most of the Unionmelt plates afforded an easier path of failure. Preheating or stress relieving of austenitic welds would probably favor precipitation of carbides and interface failures. (3) Linear precipitation of nonmetallics in weld metal adjacent to fusion line. The majority of fusion zone failures proceed through the weld metal a few thousandths of an inch from the true fusion line. The fracture has the characteristic scaled appearance of plate Midland RE-104 in Figure 11. Microscopic examination of a number of austenitic welds reveals a fine precipitation of nonmetallic inclusions lined up parallel to the fusion line. This condition is illustrated in the two center photomicrographs of Figure 18. The lining up is in contrast to the random distribution of nonmetallics throughout the remainder of the weld metal. An attempt is being made to connect this phenomenon to the observed tendency for greater fusion zone cracking in austenitic welds made with certain armor compositions, and photomicrographs are now available which clearly indicate that a majority of fusion zone failures proceed through the area of lined-up inclusions.

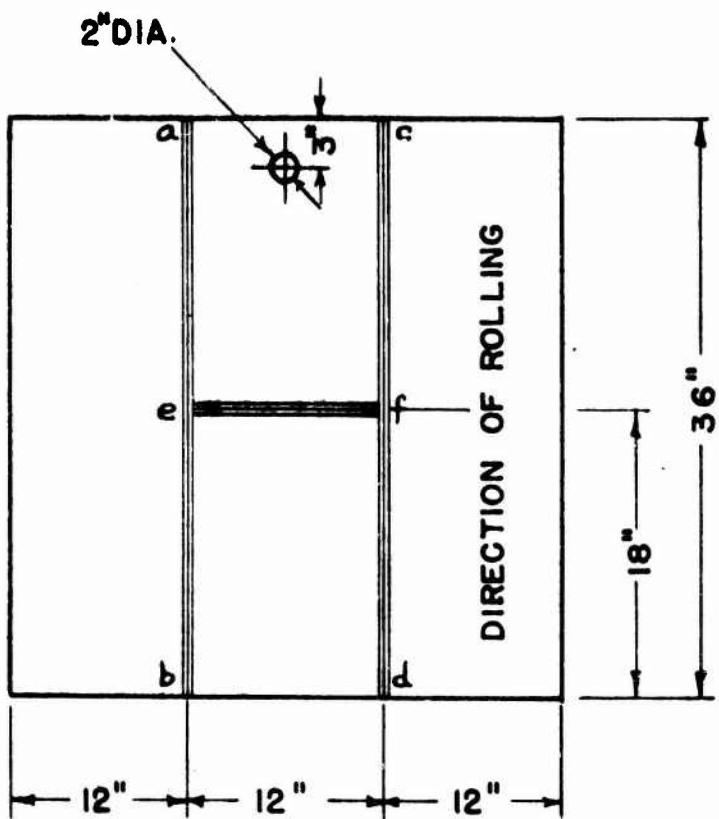
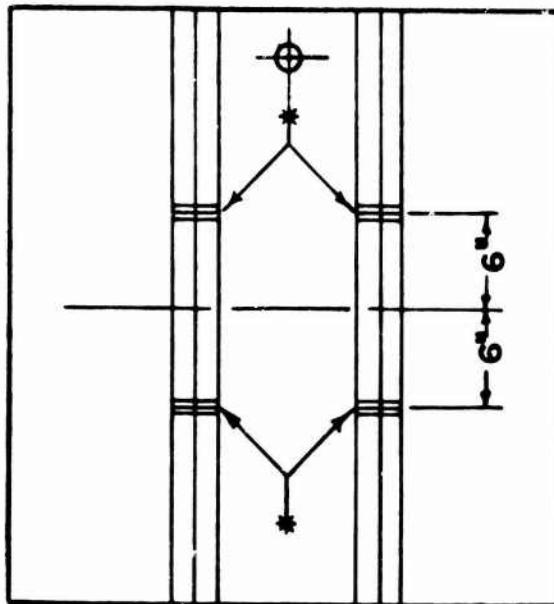
FIG. 1

**WELD SEQUENCE:**  
*ab, cd, fc.*

### QUALIFICATION SHOCK TEST PLATE

\* INTENDED AIMING POINTS
